Technology in Action

IN-FRC Heavy Duty Pulling Tool | Heavy Duty Releasable Spear

UK-based Operator, North Sea

Retrieval of Sub-Surface Safety Valve (SSSV) with damaged Fish Neck.

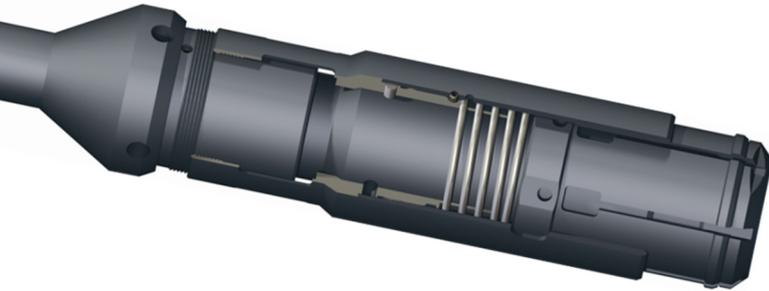
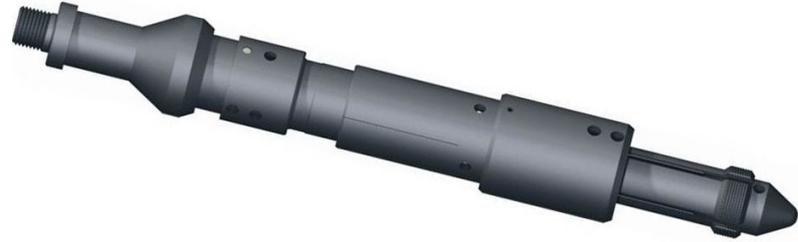
Peak's 7" IN-FRC Heavy Duty Pulling Tool has full radial contact allowing 30% more contact with the Fish Neck than a standard GS Pulling Tool. Fitted with Serrated Dogs for additional internal grip it was able to latch but pulled free from the Fish Neck on every attempt - this confirmed that damage to the Fish Neck was extensive.

After a few attempts to latch it was found to be free to take a large over-pull. With this confirming that the Fish Neck of the SSSV had successfully been latched, jarring commenced - the SSSV was successfully pulled to surface where severe damage to the Fish Neck was observed by the operators.

It was therefore decided with the Customer to use Peak's 5 1/2" Heavy Duty Releasable Spear fitted with the Long Adjustment Sleeve to ensure shear off capabilities should this be required. The viability of this option was proven following trials on a similar lock onshore to ensure latching was the best fit possible.
