Technology in Action

OD Heavy Duty Releasable Spear

UK-based Operator, North Sea

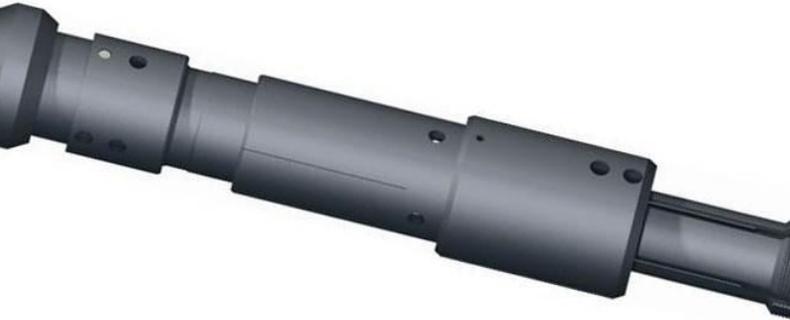
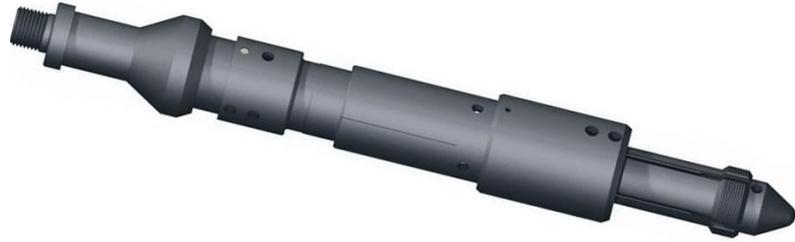
4.5" OD Heavy Duty Releasable Spear.

During the onshore trial it was established that the Crossover could only be located at the smaller ID where it would make contact with the poppet of the Injection Valve. The Injection Valve required 125lbs minimum force to compress the Poppet and the full travel to open the Injection Valve was 5.52". With the Poppet fully compressed this would allow the Peak Releasable Spear to locate the inner ID on the Crossover.

Following rapid mobilisation of Peak's 4.5" OD Heavy Duty Releasable Spear to the offshore platform it was successfully run in hole to the location of the Crossover at 9,901ft. After the latching process the pick-up weight increased 100lbs confirming the 4.5" OD Heavy Duty Releasable Spear had a grip of the Injection Valve.
