Technology in Action

eCutter used to free wire at depth and retrieve to surface in high deviation wellbore

UK Operator, North Sea

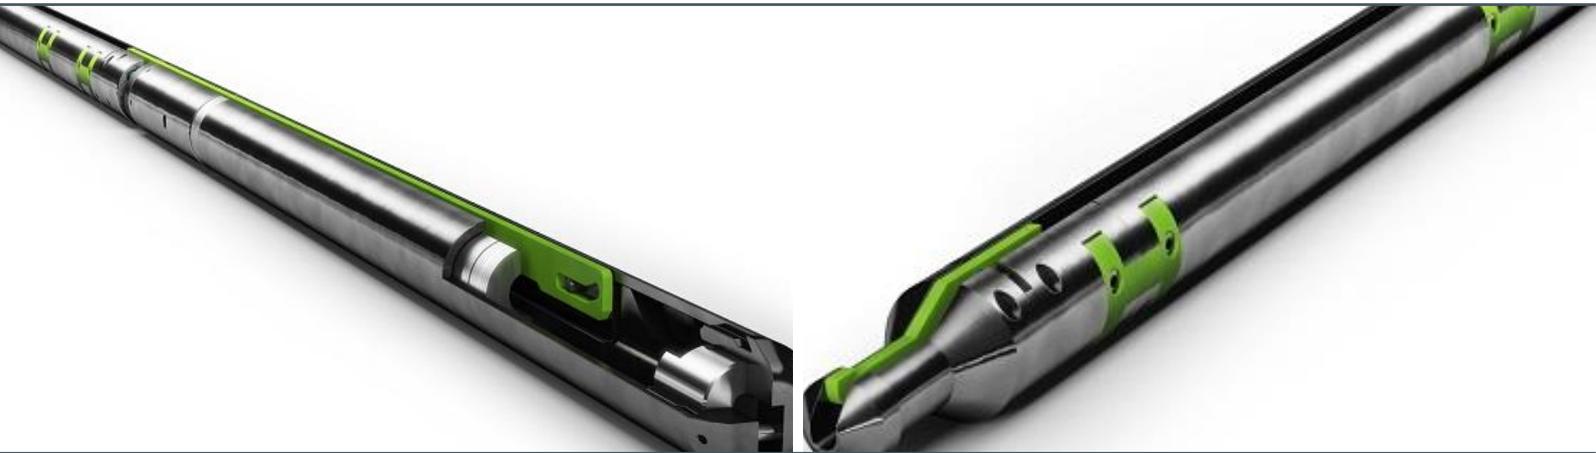
After careful review of the well design and discussion with the customer, the preferred option for cable release was to deploy the 2.20" Peak eCutter and Pump Down Go-Devil assembly with 3.65" swab cups to ensure the cutter reached the correct depth and cut at the rope socket which was located at 65 degrees of deviation.

The Peak eCutter was set to delay for a period of six (6) hours before being deployed downhole followed by the Pump Down assembly that pumped slowly at 3bbls/min enabling the eCutter to reach the required cutting depth of 2,349m (93 degrees C; 1,600psi). After six (6) hours, the eCutter was activated and successfully cut the wire at the rope socket whilst at the same time gripping the severed wire.

Both the eCutter and Pump Down assembly were then retrieved to surface along with the wire allowing the customer to continue with their planned sidetrack.
